AFRL-SA-WP-SR-2015-0011

Composite Material Hazard Assessment at Crash Sites

Update, 2015

January 2015

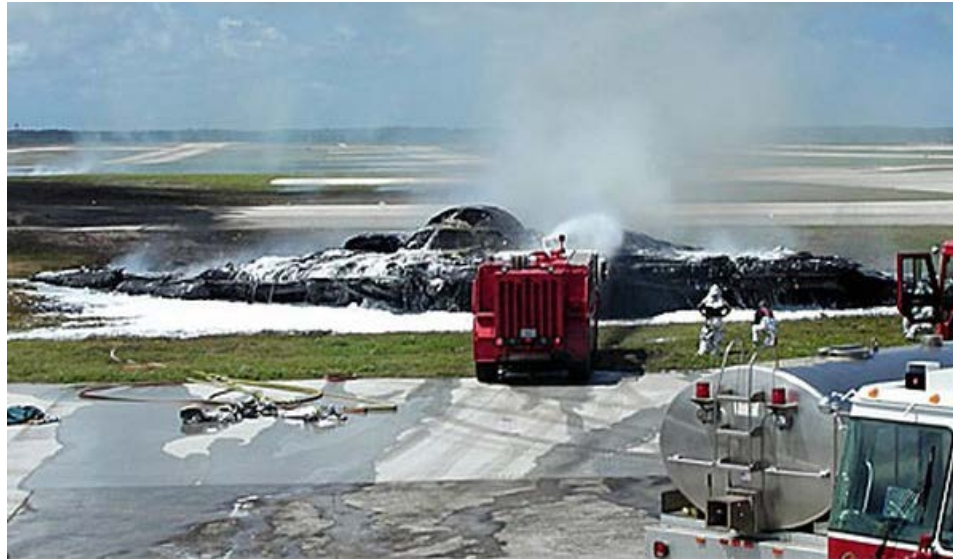
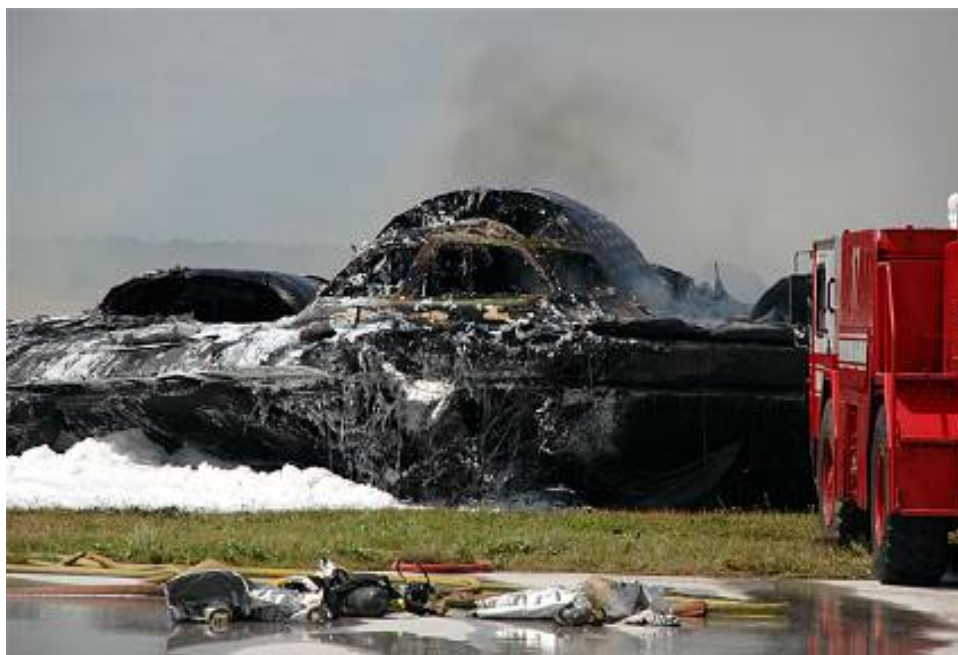
APPENDIX A: B-2A CRASH (89-0127) ON 23 FEB 2008

1. The following two pictures show the debris from the B-2A crash.

Initial ground contact occurred when the left wing tip hit the ground causing fracture damage to the wing tip and wing tip support structure. The aircraft continued upwind then descended to hit the ground with the nose gear and then the left main landing gear. Upon ground impact the left main landing gear separated from the aircraft releasing fuel. This caused a fireball to travel upwind scorching an area of approximately 29.517 m². The left main landing gear rested 475 m from the final position of the aircraft. The bomb bay and nose landing gear doors, located at 350-400 from the aircraft showed signs of physical damage with little or no scorch markings. Ground scars show the aircraft came to rest 717 m from initial ground contact. The pilot (left) seat rested 458 m from the aircraft. The co-pilot seat rested 431 m from the aircraft. The hatches were located 568 m and 578 m from the aircraft. The debris field was comprised of random pieces and fragments of composite materials ranging in size and shape with very few metal pieces found. Most of the aircraft structure remained intact but with severe impact damage as it came to rest on its bottom outer mold line. The survey determined the debris field area was 18,964 m².

The B-2A was designed with approximately 80% composite material and 20% aluminum and titanium as the substrate materials. The carbon fiber / epoxy composite system is the primary composite materials system; although there are other composite systems found in small quantities like fiberglass / PMR-15. JP-8 pool and fireballs can create flame temperatures in excess of 2000°F and “time at temperature” determines the degree of damage for these materials. As the flame-front penetrates through the composite thickness, layers burn and metals melt. The wreckage showed varying degrees of impact and thermal damage. The B-2A aircraft sustained severe thermal damage.

Aircraft materials show signs of thermal damage that help to determine what the temperatures could have been. Melting point, color change and recognition of surface feature changes were used to evaluate the wreckage. The following materials were used as indicators of temperature exposures: carbon fiber, glass, titanium, aluminum, silver, nickel, iron, copper, epoxy and polyurethane coatings, and polycarbonate. The inboard and outboard wing assembly wing tips, leading and trailing edge showed signs of thermal exposure of at least 1700°F. The crew station assembly showed signs of at least 1200-1 500°F. The center body was at least 1200°F. The aft wing assembly, GLAS, hot trailing edge and decks were exposed to at least 900-1 100°F. The bottom outer mold line condition will remain unknown until the wreckage is moved.

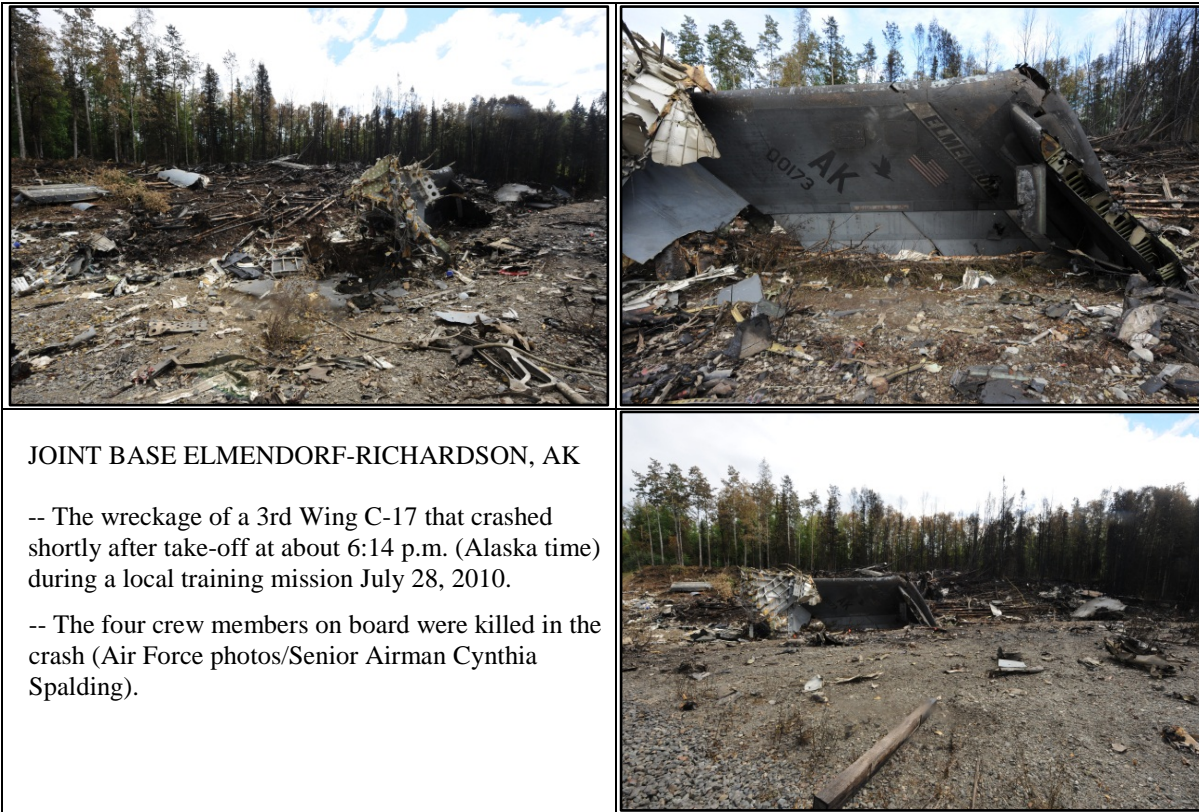
APPENDIX B: PICTURES OF THE C-17 CRASH FROM 28 JULY 2010

A C-17 aircraft from Elmendorf AFB, Alaska, crashed off base at a remote location on 28 July 2010. Firefighters sprayed a fixant solution of water and wax on any parts that appeared to be ACM. Due to the austere conditions and frequent rain, BEF collected no personal air samples; however, direct reading instruments (DRIs) measured particle and aerosol mass concentrations. A condensation particle counter and optical particle counter were the DRIs measured particle and aerosol mass concentrations, respectively [10]. Sampling continued for 3 days of crash site recovery operations in close proximity to workers who were engaged in cutting operations on the vertical and horizontal stabilizers of the aircraft. The average particulate mass concentration as measured by the DRIs over the 3 days was 1.71 mg/m³, which is less than USAFSAM's recommended OEEL for respirable particulate of 3.0 mg/m³. Measured concentrations reported for the DRIs include background ambient aerosol particulate, which would also include particulate from the diesel exhaust of an excavator and other equipment operating at the crash site. See Appendix B for pictures of the crash site.

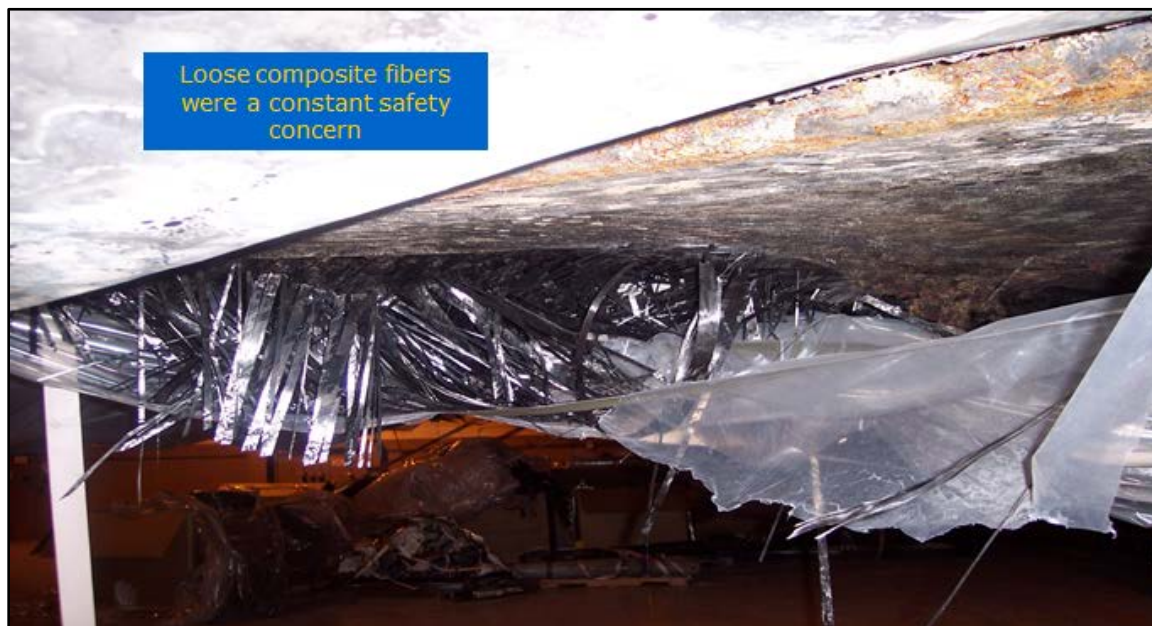
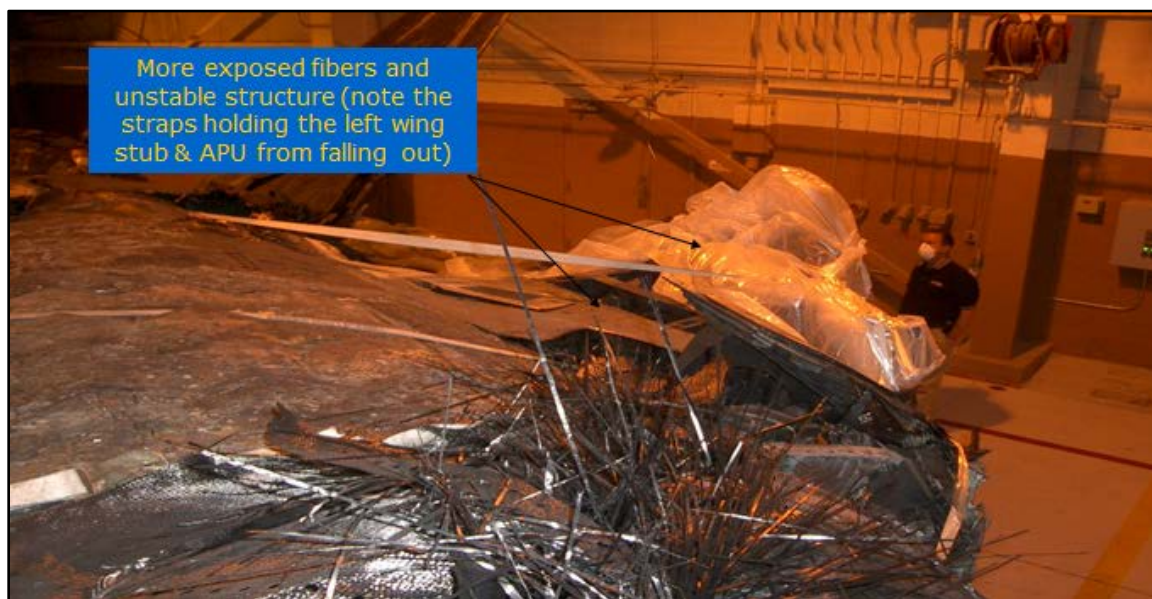
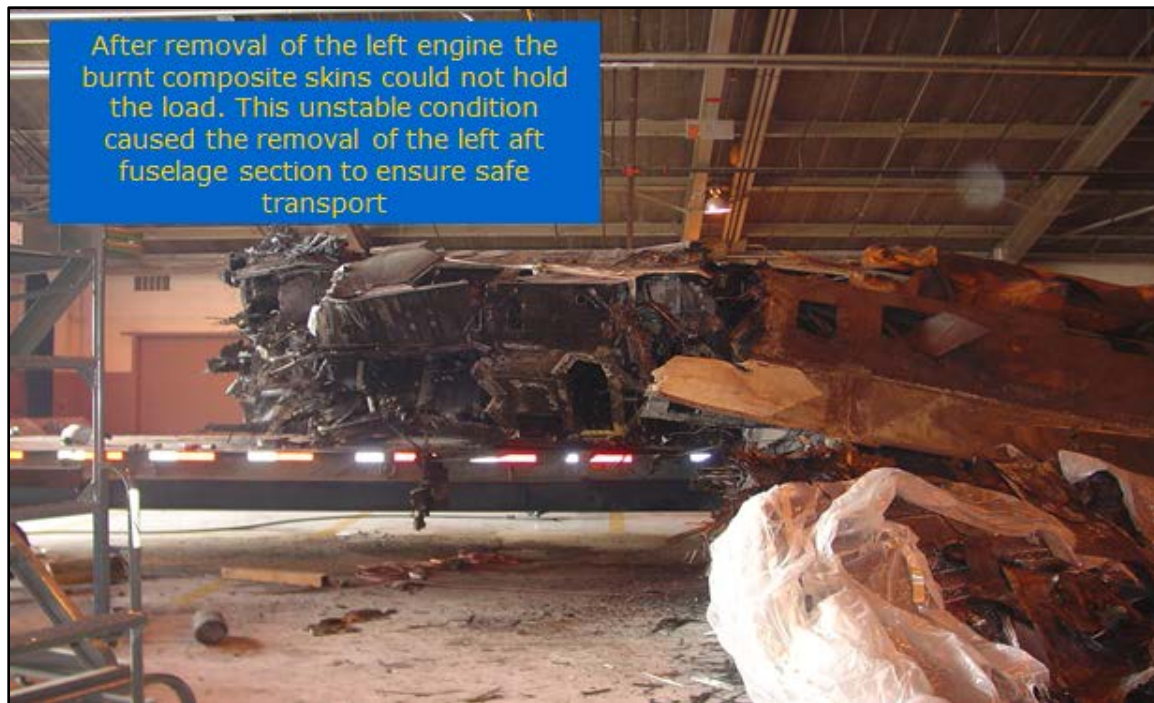
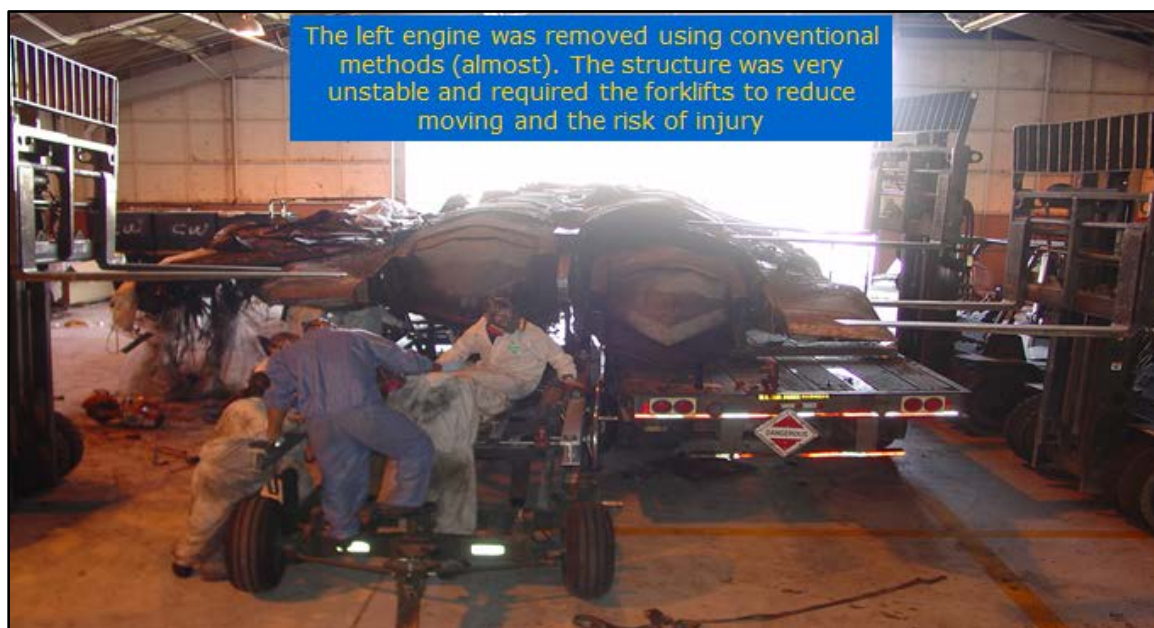
APPENDIX C: PICTURES OF THE F-22A TEARDOWN

Recommend goggles whenever material or debris is disturbed such that material can potentially become airborne. Refer to pictures of the F-22A debris in Appendix C.
