**Subject: Truax Field Air National Guard Base, Final
Perfluorinated Compounds Site Inspection Report**

**FINAL REPORT
FY16 PHASE 1 REGIONAL SITE INSPECTIONS
FOR PERFLUORINATED COMPOUNDS**

**TRUAX FIELD AIR NATIONAL GUARD BASE
MADISON, WISCONSIN**

March 2019

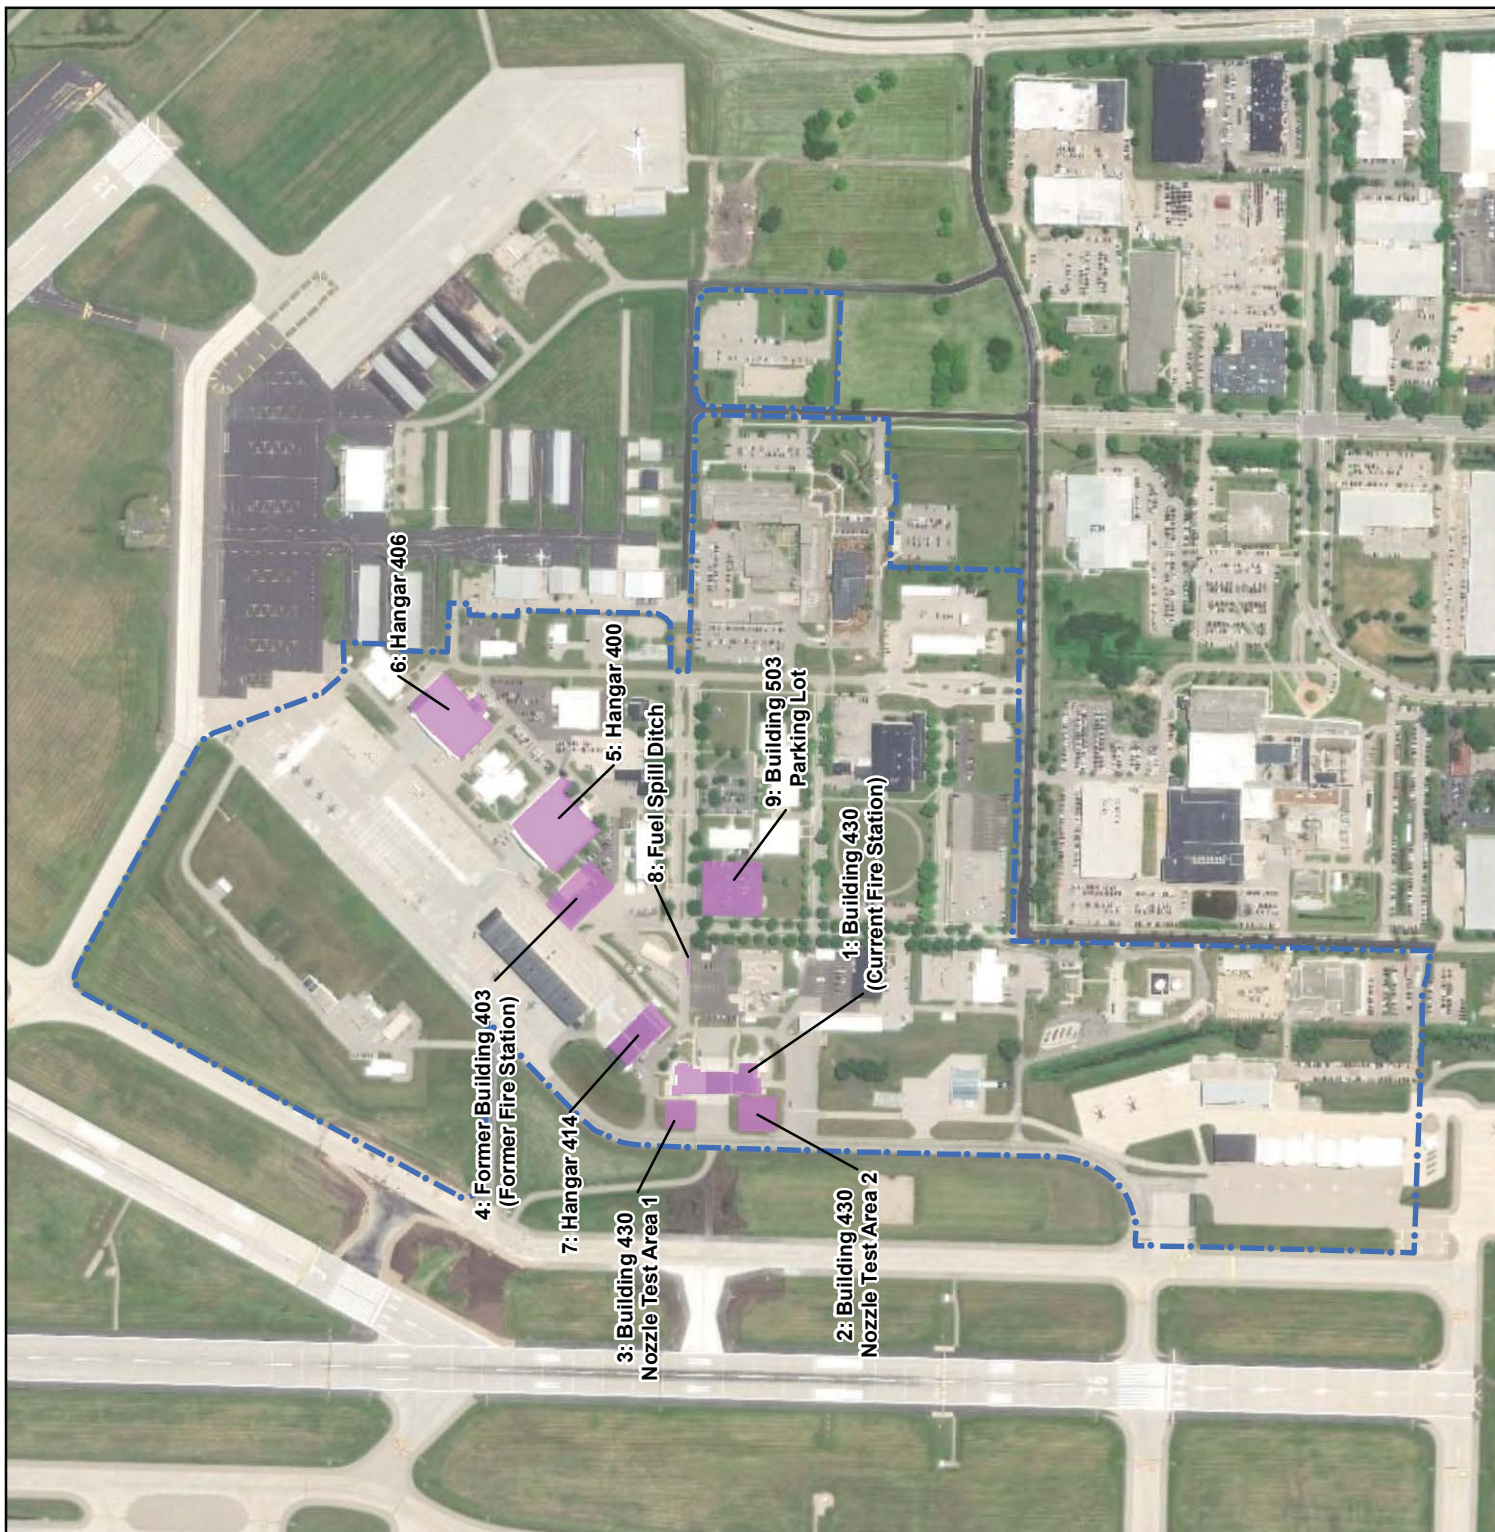
1.0 and 5.0 to 5.5 ft. bgs; 02-SB03 from 0.5 to 1.0 and 6.0 to 6.5 ft. bgs. Analytical results from soil samples indicate that the six PFCs analyzed for were detected above the laboratory reporting limit, with three samples having PFOS concentrations exceeding HA criteria of 1.26 mg/kg. Sample 02-SB02-0.5-1.0 was found to have a PFOS concentration of 3.33 mg/kg and a PFOA concentration of 0.0141 mg/kg. Sample 02SB03-0.5-1.0 was found to have a PFOS concentration of 30.1 J mg/kg and a PFOA concentration of 0.118 mg/kg. The duplicate to sample 02-SB02-0.5-1.0 was found to have a PFOS concentration of 36.8 J mg/kg and a PFOA concentration of 0.151 mg/kg.

A review of soil analytical data compared to screening criteria indicates there are no USEPA RSL exceedances for PFBS, and no USAF Guidance screening level exceedances for PFOA, at on-Base locations near PRL 1. One USAF Guidance screening level exceedance of for PFOS in the shallow soil sample was observed in boring 01-SB01 at PRL 1.

A review of groundwater data compared to screening criteria indicates exceedances of the USEPA Drinking Water HA exist downgradient from PRL 1. This determination was made based on concentrations observed in TW-01, which was installed to assess groundwater conditions downgradient from both PRL 1. Given that groundwater flows to the east/southeast, groundwater with PFC concentrations above applicable screening criteria is potentially present off-Base to the east/south of PRL 1.

A review of groundwater data compared to screening criteria indicates exceedances of the USEPA Drinking Water HA exist downgradient from PRL 2. This determination was made based on concentrations observed in TW-02, which was installed to assess groundwater conditions downgradient from both PRL 2. Given that groundwater flows to the east/southeast, groundwater with PFC concentrations above applicable screening criteria is potentially present off-Base to the east/south of PRL 2.

A review of groundwater data compared to screening criteria indicates exceedances of the USEPA Drinking Water HA exist downgradient from PRL 3. This determination was made based on concentrations observed in TW-03, which was installed to assess groundwater conditions downgradient from both PRL 3. Given that groundwater flows to the east/southeast, groundwater with PFC concentrations above applicable screening criteria is potentially present off-Base to the east/south of PRL 3.

PRLs 1, 2, and 3
ANALYTICAL RESULTS
